ENVIRONMENTAL ASSESSMENT

**PROPOSED RE-CONSTRUCTION of the
GUAM FISHERMEN'S COOPERATIVE ASSOCIATION
FACILITY**

HAGATNA, GUAM

MARCH 2016

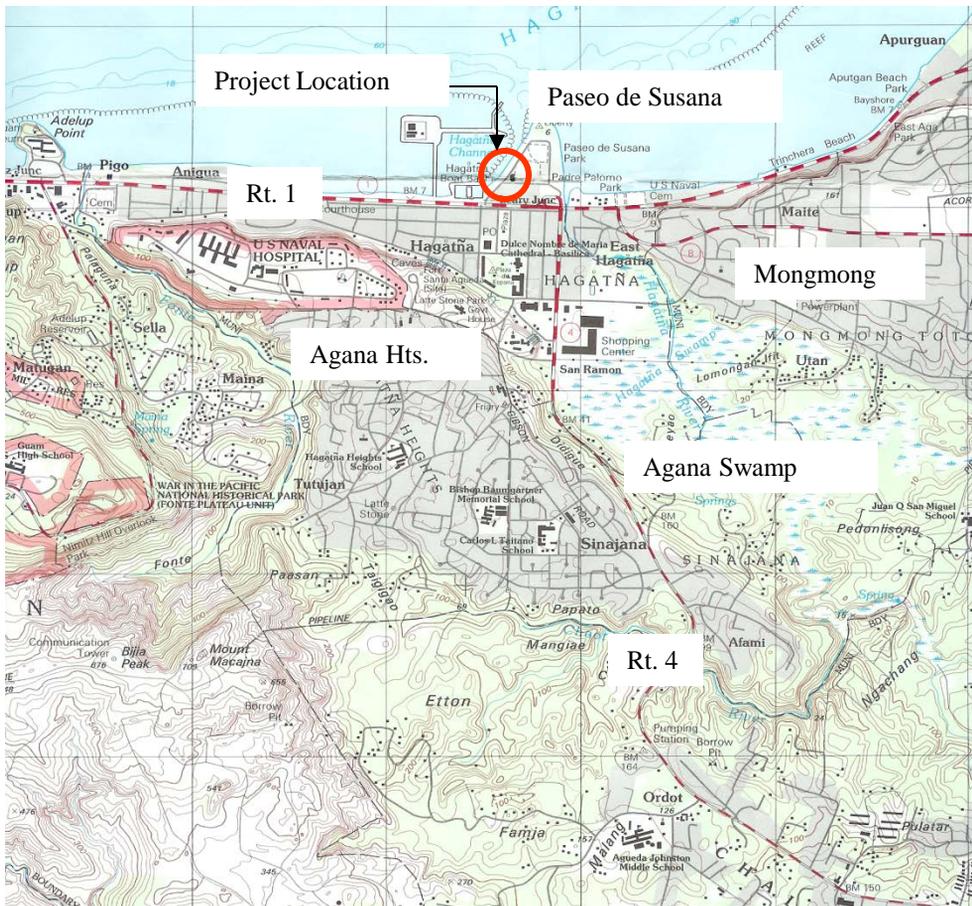
Figure No.
1

**Guam Fisherman's Co-Op Project
Location/Vicinity Map**

The existing Co-Op facility is located on Lot No. A-4 (Paseo de Susana) between the Gregorio D. Perez Marina and the Paseo complex in Hagatna (Figure 1 – Location/Vicinity Map). Lot No. A-4 comprises an area of approximately 3,000 sm. As a result of Public Law 27-24, the adjoining acre of shoreline property to the north east was leased to the Co-Op for future expansion purposes. The existing building structure is in such dire need of repair that total structure replacement is the best option. Years of deterioration and damage from storm events have undermined the structural integrity of the existing facility. The Co-Op Board of Directors has made the decision to demolish the current facility and construct a replacement in the same location. Appendix A includes photographs of the existing facility and the surrounding area. Figure 1 also highlights important features surrounding the project area. The aerial photograph (Figure 2) shows the spatial relationship of the existing Co-Op facility to the surrounding community.

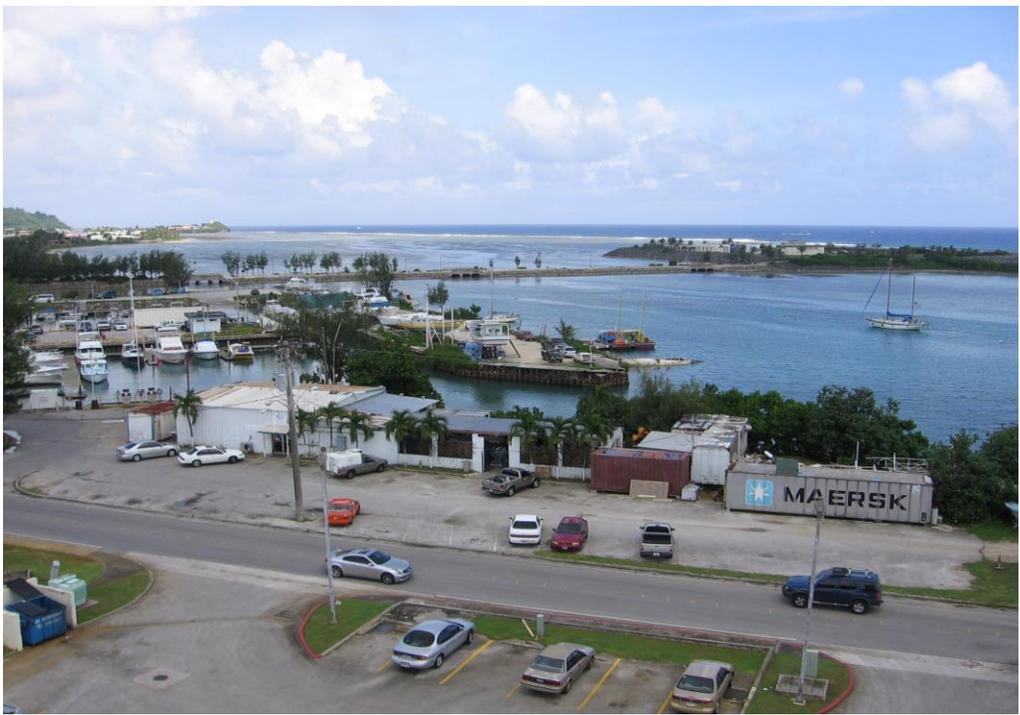
1A

1A: View of Co-Op complex from the east

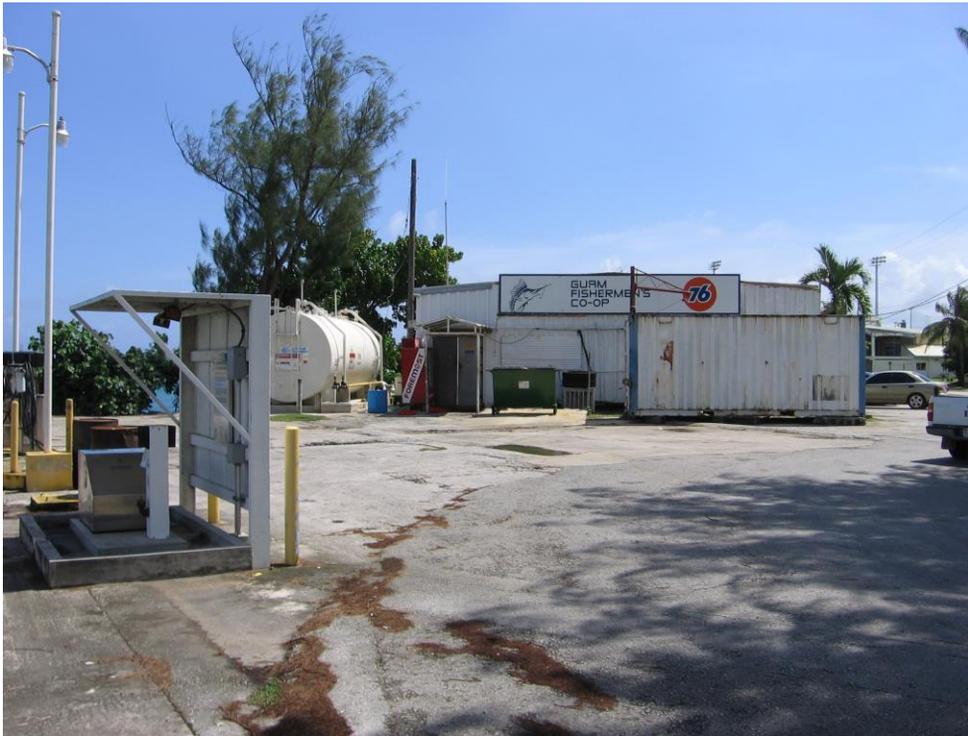
1B

1B: Co-Op unloading area, pump out facility and AST from the south

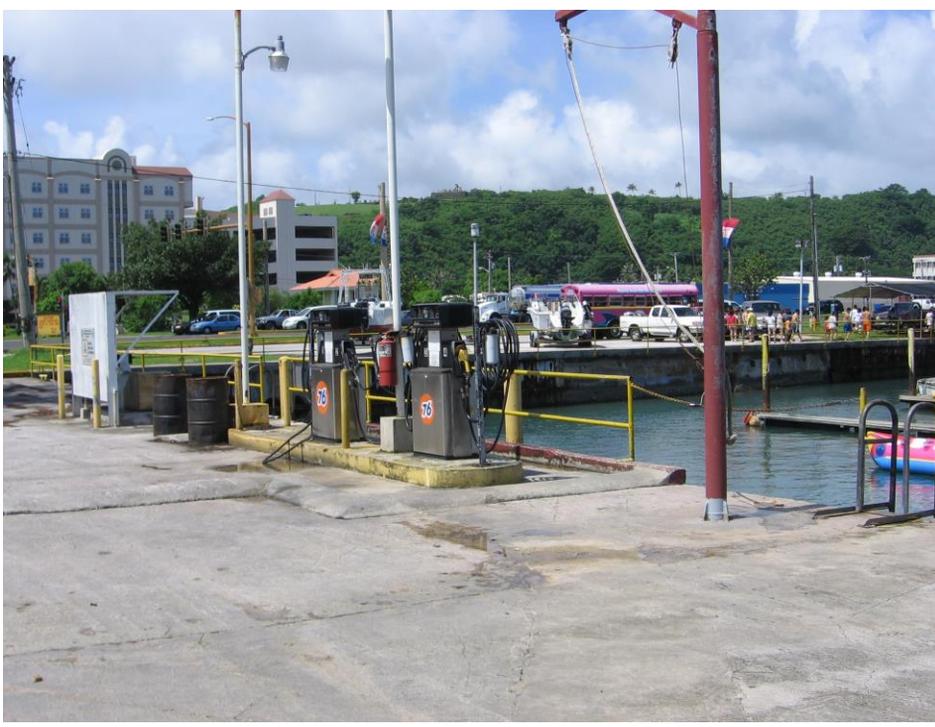
2A

Compounding the lack of diverse natural habitat, is the degraded water quality within the general vicinity of the project area. Storm water pipes discharge directly into Hagatna boat basin, approximately 100 feet from the Co-Op building near the fuel pumps (Photo 2A). This discharge negatively affects water quality and the magnitude of the effect is related to the rain event and the contaminants (unknown) that may be contained in the discharge. An additional compounding contributor to vicinity water quality problems is the presence of the Hagatna marina facility, also located at the Co-Op, which acts to inhibit the flushing rate of the harbor area.

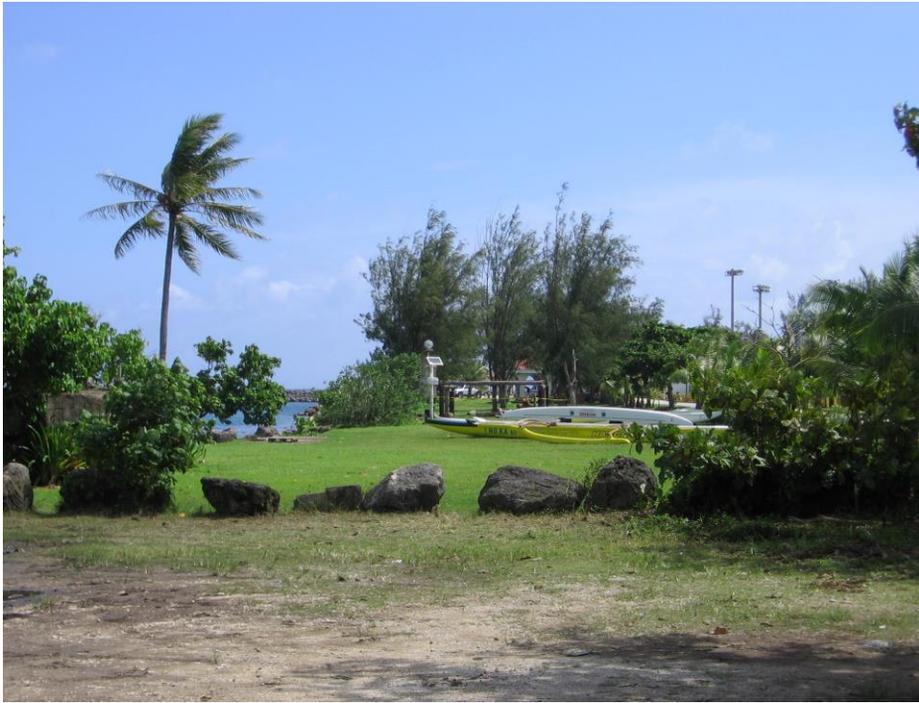
3A

3A: View of acre north of Co-Op facility provided for expansion
3B: WWII bunker located on additional acre to the north

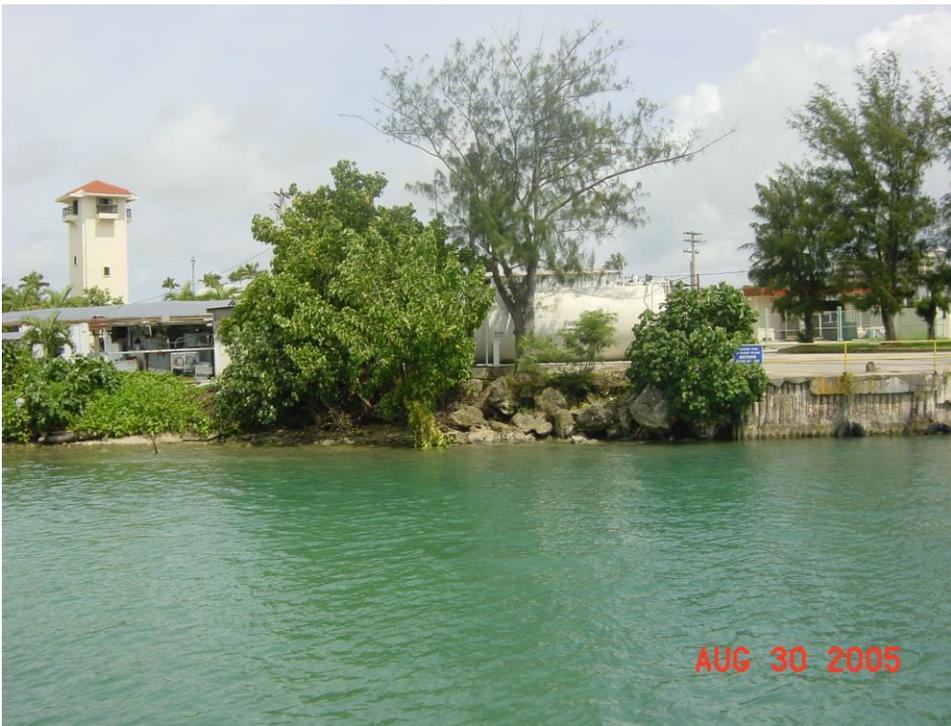
4B

4A: Agana Marina channel entrance
4B: Shoreline fronting Co-Op building

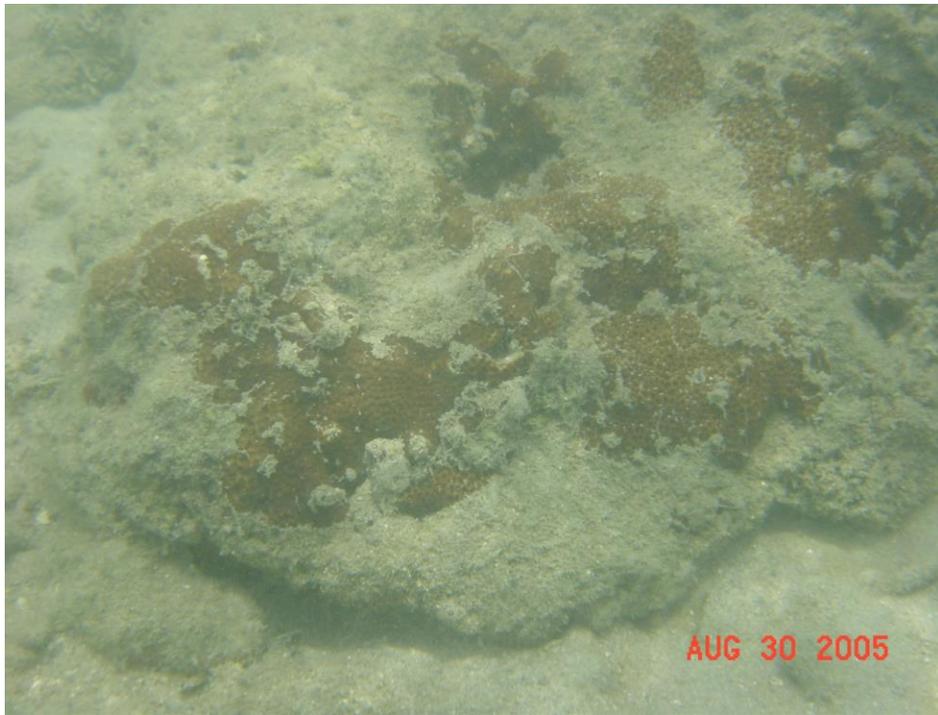
5A

5A: View of coral showing sedimentation levels

The constant vessel traffic in the nearby Hagatna boat basin entrance channel likely maintains elevated turbidity levels. Some corals were observed secreting mucus (a natural response to sedimentation) and showing signs of accumulated sedimentation (Photo 5A).

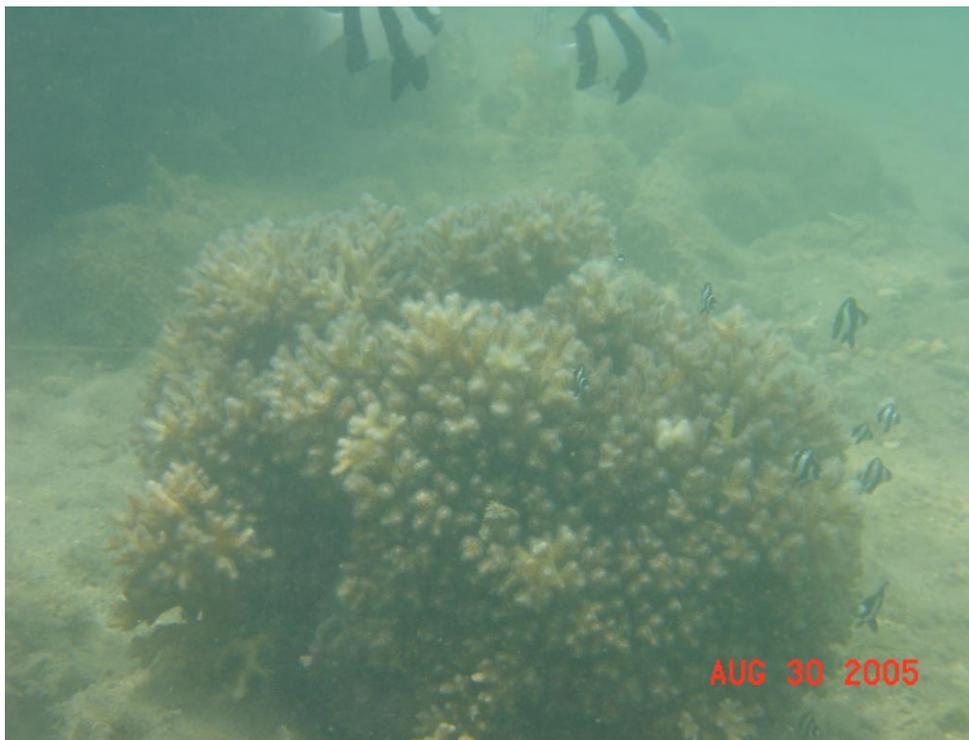
5B

5B: View of the common coral (*Pocilipora damicornis*)

Fish species observed included both adult and juvenile humbug dascyllus (*Dascyllus aruanus*) and blue-green chromis (*Chromis viridis*) that was usually associated with the *Pocillopora damicornis* corals (Photo 5B). Juvenile individuals of Moorish idol (*Zanclus cornutus*), convict surgeonfish (*Acanthurus triostegus*), pennant bannerfish (*Heniochus chrysostomus*), yellow boxfish (*Ostracion cubicus*) and the raccoon butterflyfish (*Chaetodon lunula*). Other more benthic species, such as pipefish (Syngnathidae) and several species of unknown obiidae were observed in/on the sand/silt substrates.

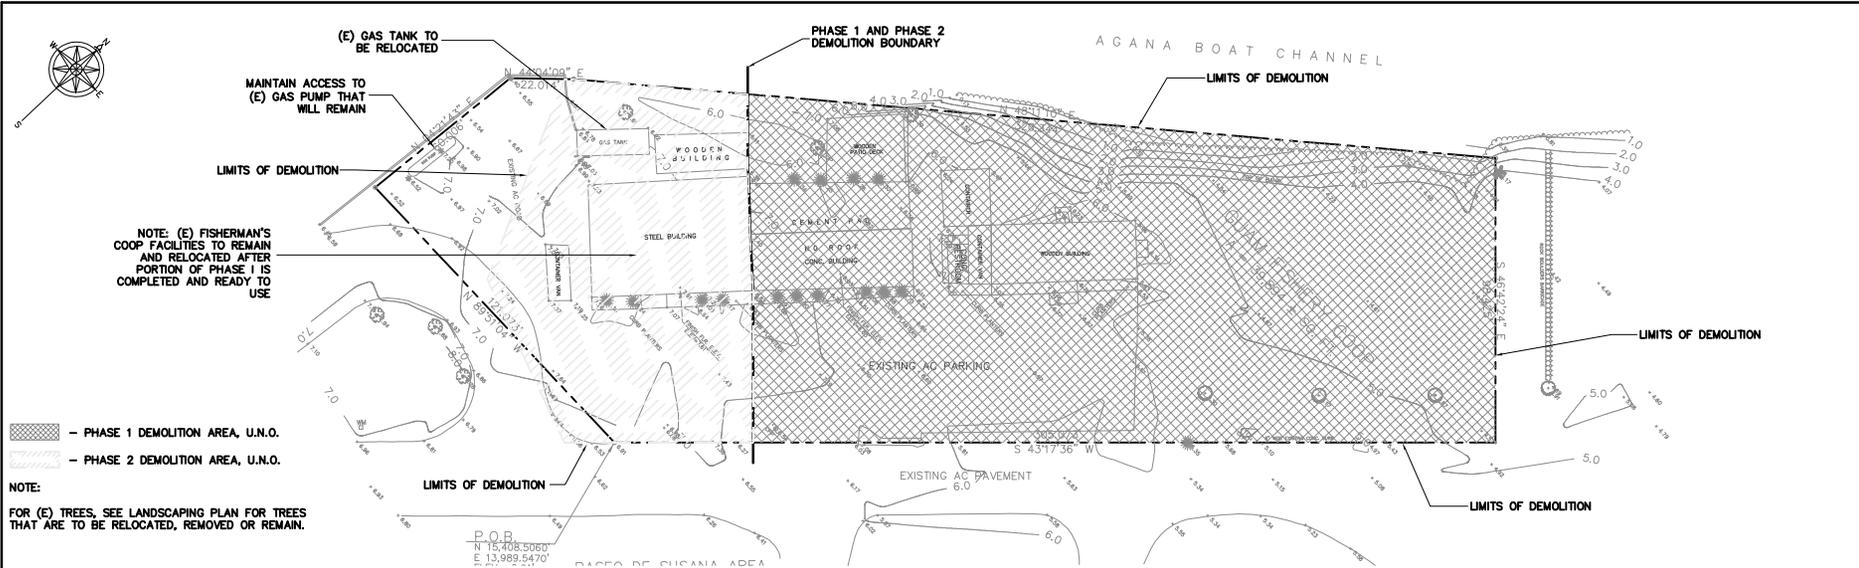
1 DEMOLITION PLAN
 C-2 1"=20'

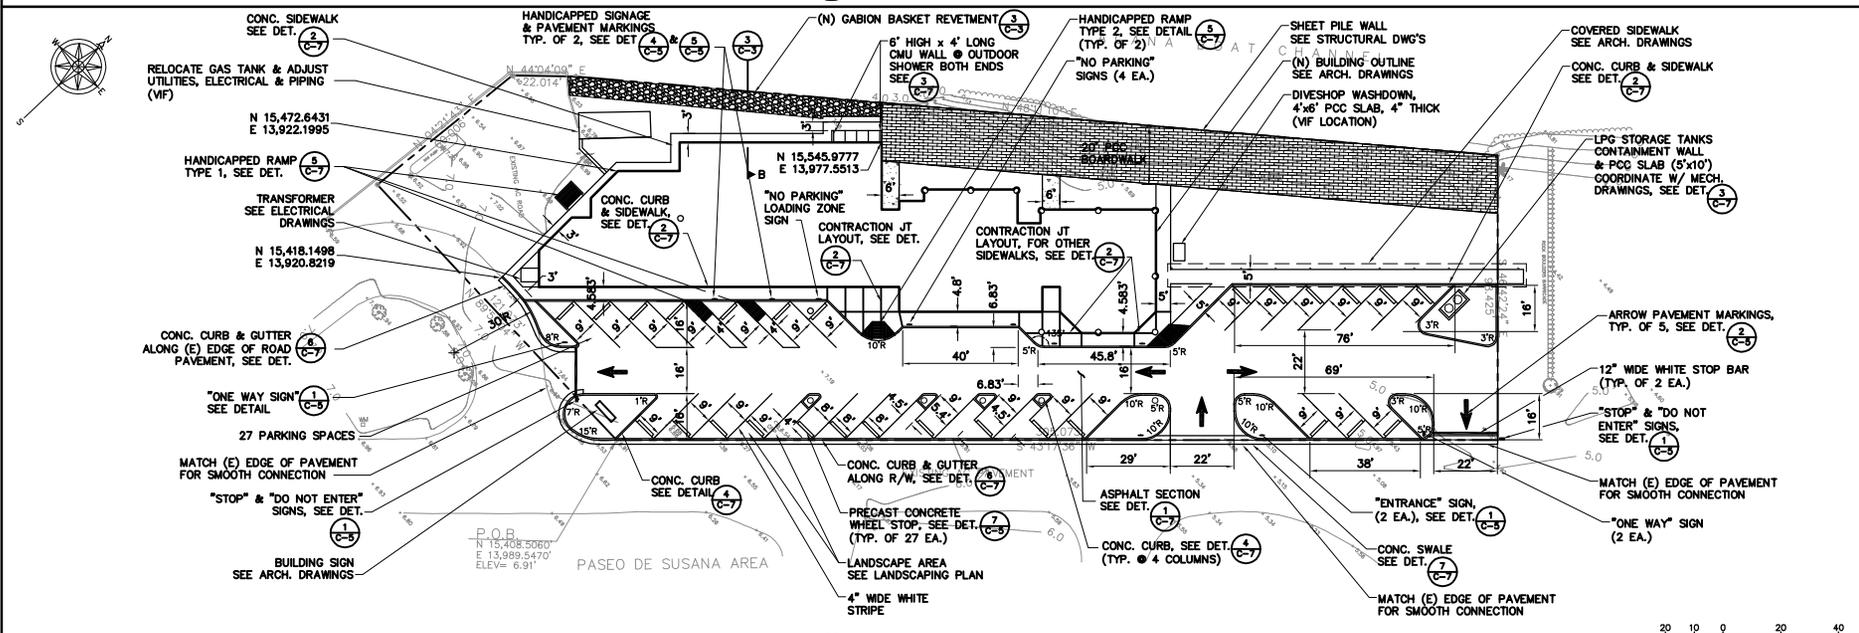
2 SITE LAYOUT PLAN
 C-2 1"=20'

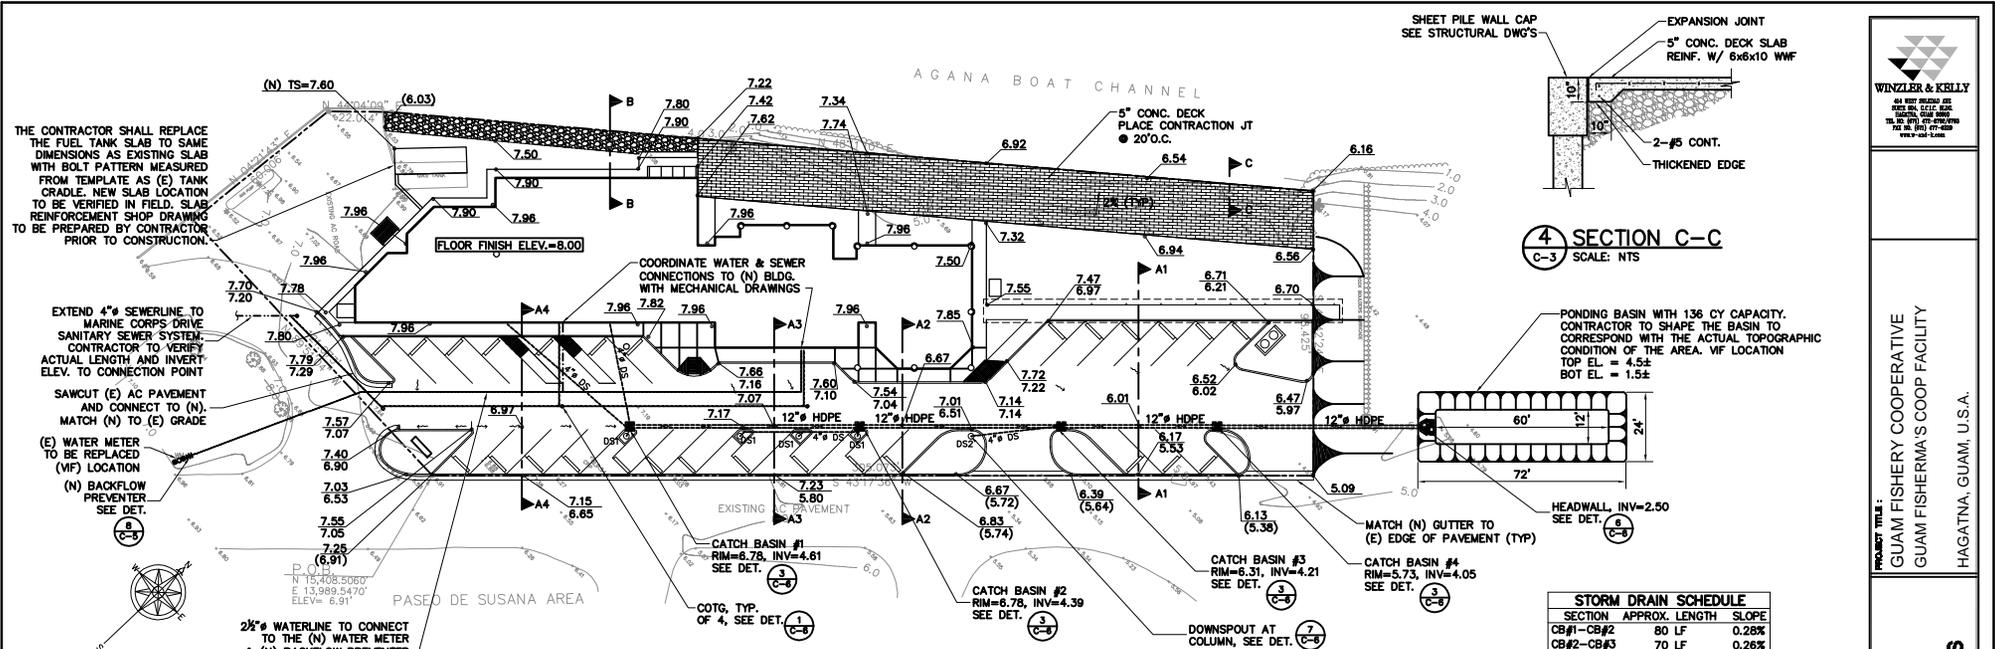
4 SECTION C-C
C-3 SCALE: NTS

SECTION	APPROX. LENGTH	SLOPE
CB#1-CB#2	80 LF	0.28%
CB#2-CB#3	70 LF	0.26%
CB#3-CB#4	55 LF	0.29%
CB#4-HW	70 LF	2.21%

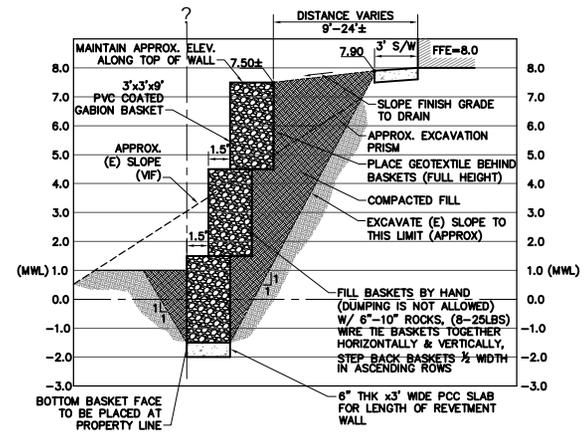
3 SECTION B-B (L=110 LF)
GABION BASKET RETEMENT
C-3 SCALE: HOR.=1:4 VERT.=1:2

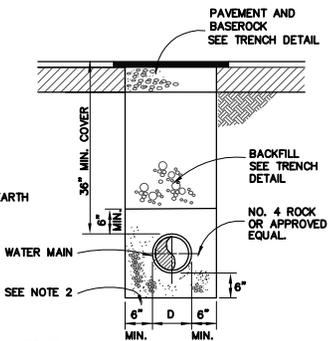
NO. 4 ROCK		
SIEVE	% PASSING	MIN. MAX.
3/4"	100	-
3/8"	80	90
#4	10	15
#8	0	5

4 TYP. PIPE BEDDING
C-6 NTS

- NOTES:**
- ANY OVEREXCAVATION SHALL BE BACKFILLED WITH AN APPROVED BEDDING MATERIAL.
 - PIPE DIAMETER 18" OR LESS: 6" MIN., 9" MAX. PIPE DIAMETER GREATER THAN 18": 9" MIN., 12" MAX.

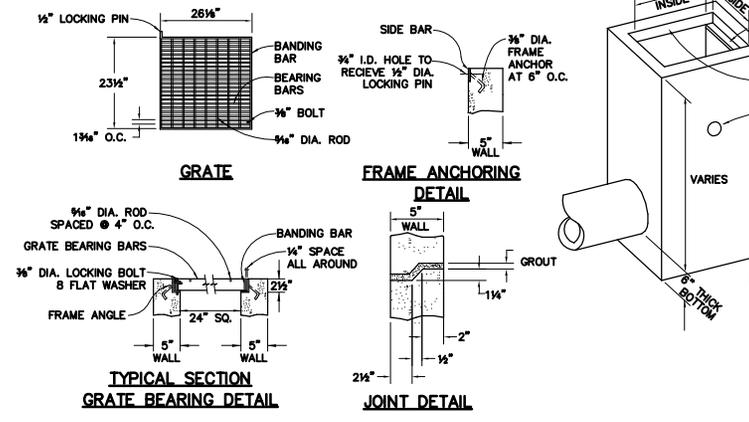
3 PRECAST CONCRETE CATCH BASIN
C-6 NTS

- NOTES:**
- GRATE MATERIAL TO BE: 2" BEARING BARS, 2 1/4" x 3/4" 2-BANDING BARS, 2" x 3/4"
 - GRATE FRAME MATERIAL TO BE: 2 1/2" x 1 1/2" x 3/4" ANGLES 2 1/2" x 1/2" SIDE BARS
 - GROUT JOINTS BETWEEN UNITS OVER 5 FT. HIGH.
 - REINFORCE WALLS & BOTTOM WITH #4 @ 6" O.C. BOTH WAYS
 - CONTRACTOR SHALL MATCH FINISH GRADES WHERE INSTALLED IN SWALE

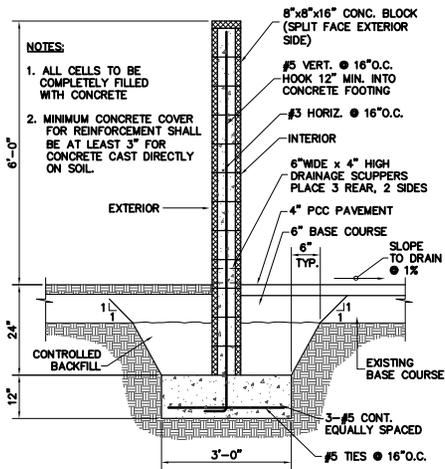
3 LPG TANK ENCLOSURE WALL
C-7 NTS

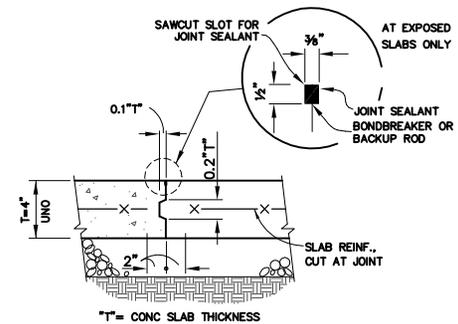
8 TYPICAL CONSTRUCTION JOINT IN CONCRETE SLAB ON GRADE
C-7 NTS

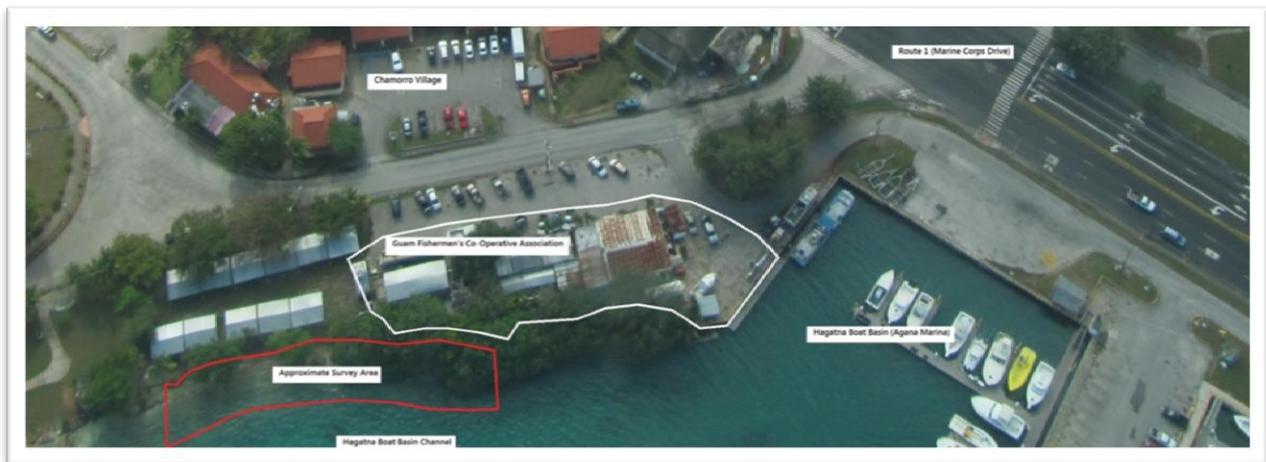
Figure 2 Approximate survey area outlined in red.

zones within the proposed dredge/fill area, each with three sections (Table 1). The survey area was extended three feet outside of the original survey area – sections J, K and L (Table 1) to include the area immediately adjacent to the proposed area of impact. Though ancillary, the added three feet was surveyed in order to record data of coral presence and abundance in the area immediately outside of the proposed project area which may also be impacted by the proposed project activities.

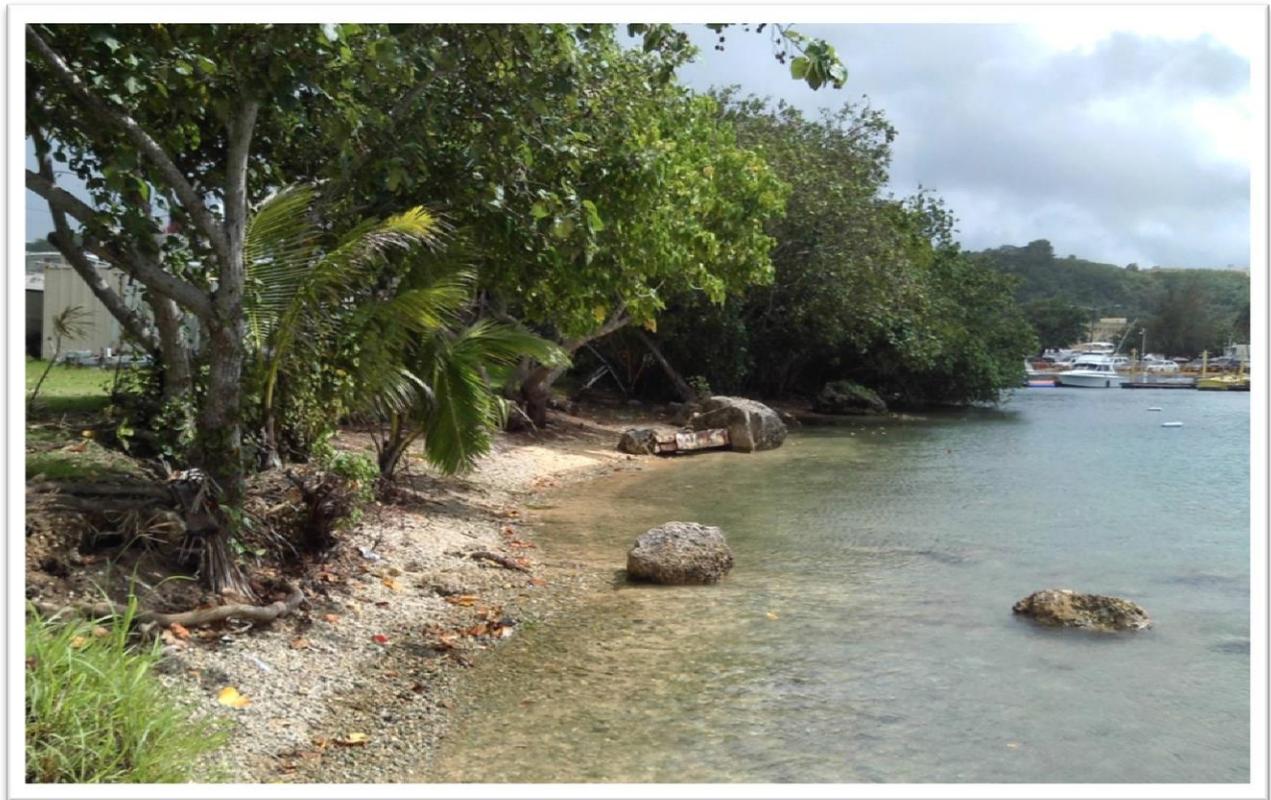
Figure 3 Sample of the shoreline at the time of the survey, which was done between 2:00 and 3:30 PM. The darker band of rocks above the water line shows the level of fluctuation of the shoreline.

The survey was conducted in the afternoon, between 2:00 and 3:30, with the second high tide of 1.7 feet at 3:46 PM. Wake from watercraft traversing the Hagatna Boat Basin Channel may have affected the shoreline for this period. The shoreline was defined by the location of the edge of the water line at that time (Figure 3), though a distinct dark band is visible and indicates the level of fluctuation in the shoreline.

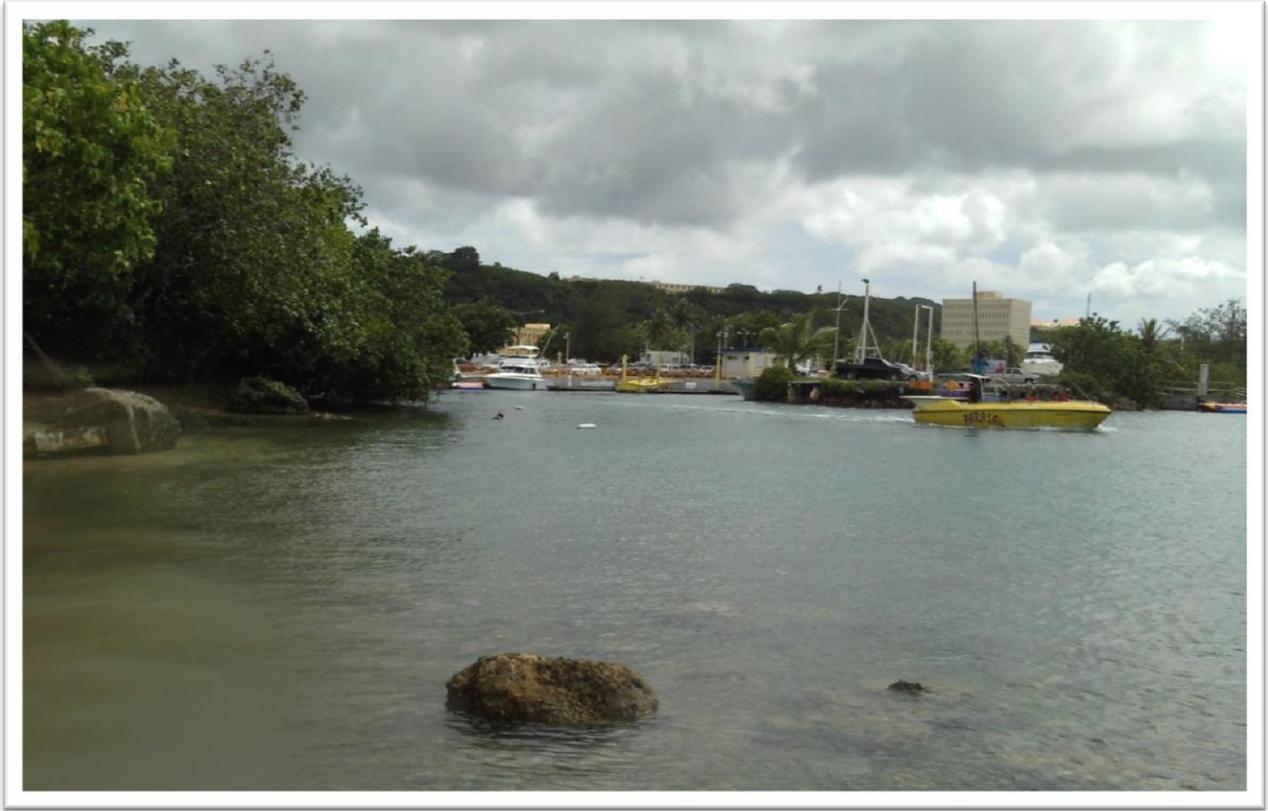
Figure 4 View of the survey area looking south, into the Hagatna Boat Basin. Buoys mark the survey corners and midpoint approximately 30 feet away from the shoreline.

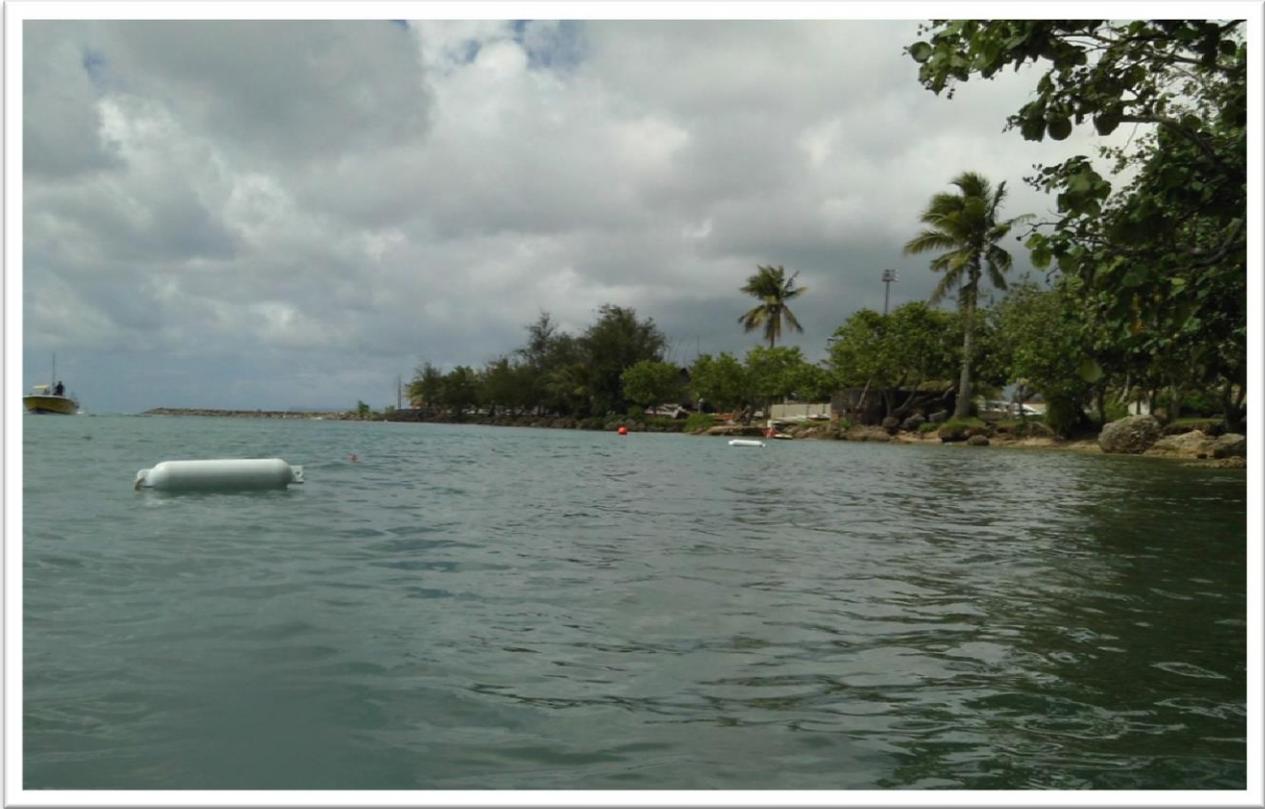
Figure 5 View of the survey area looking north, away from the Hagatna Boat Basin. Buoys mark the survey corners and midpoint approximately 30 feet away from the shoreline.

The length of the survey area extended from the northern end of the Co-Op property, furthest away from the Hagatna Boat Basin, to 215 feet toward the Hagatna Boat Basin. A tape was used to measure 30 feet from the property shoreline (Figure 3). Buoys were used to mark the corners and approximate mid-point survey area away from the shoreline (Figure 4). The survey area was organized into three

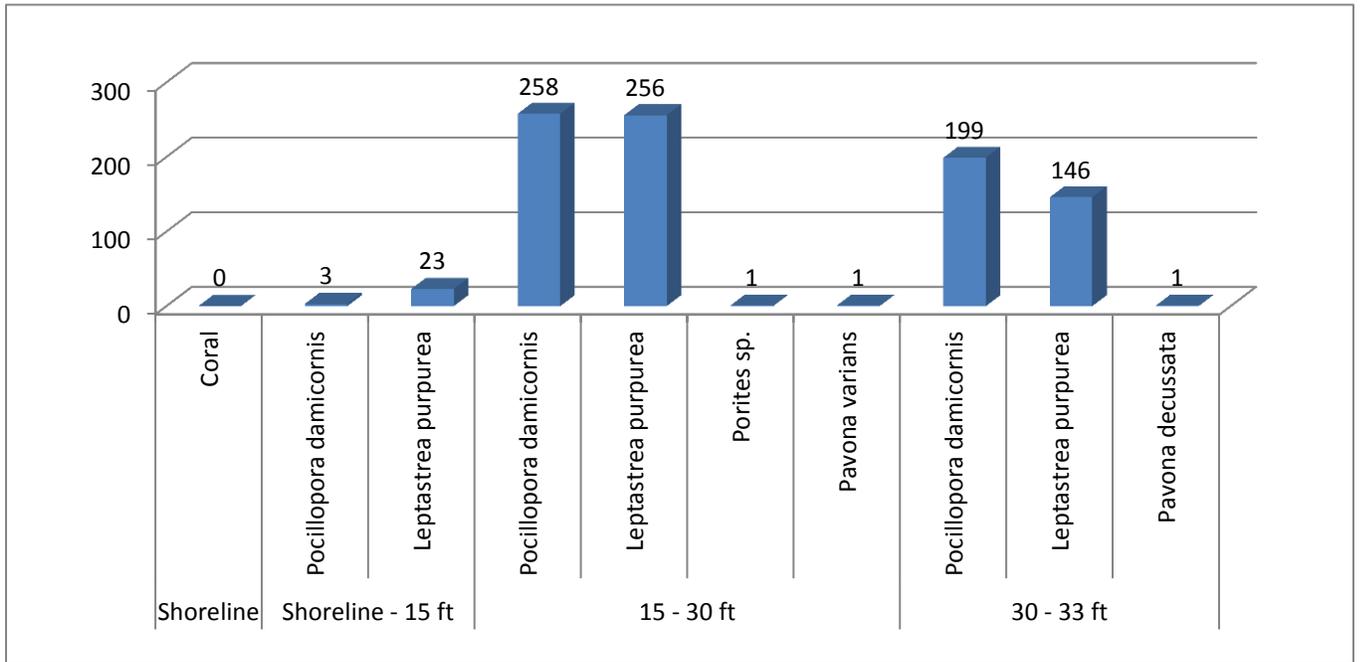
Figure 6 Graph of the data collected per zone, moving from the shoreline to approximately 33 ft away from the shoreline, toward the Hagatna Boat Basin Channel.

Based on the coral count, the two dominant coral species were *P. damicornis* and *L. purpurea* which was 51.80% and 47.86% of the total number of coral colonies recorded (Table 4).

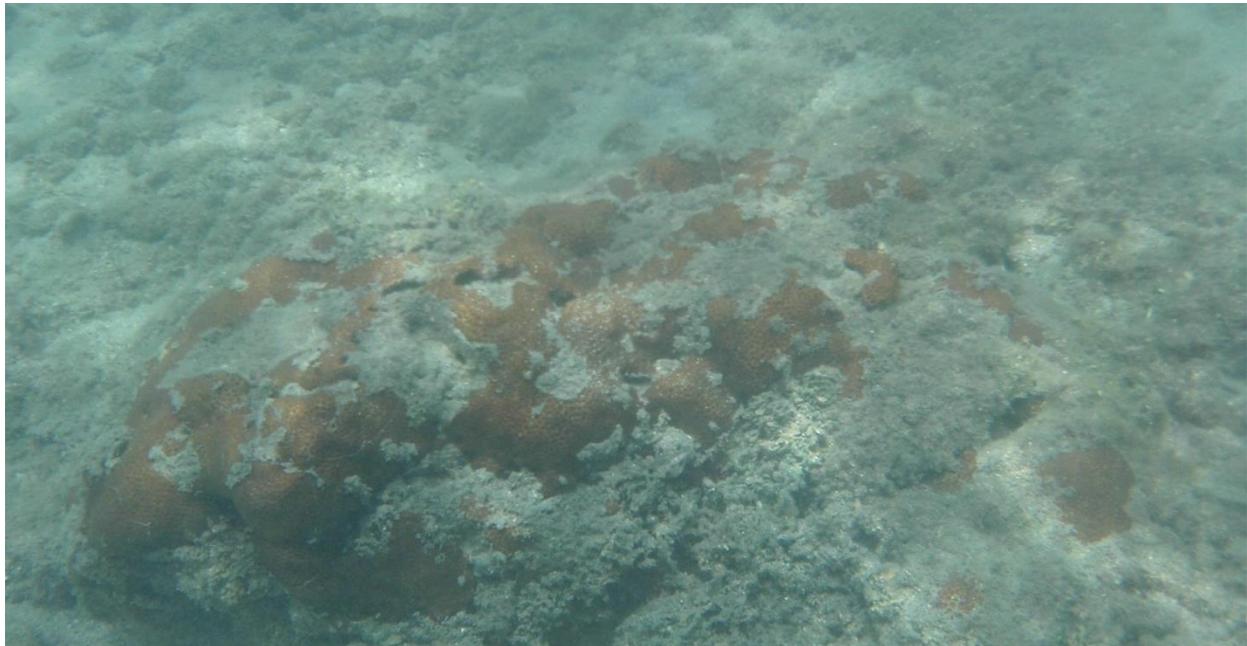
Figure 6 *Pocillopora damicornis* (branching coral) and *Leptastrea purpurea* (massive coral) colonies.

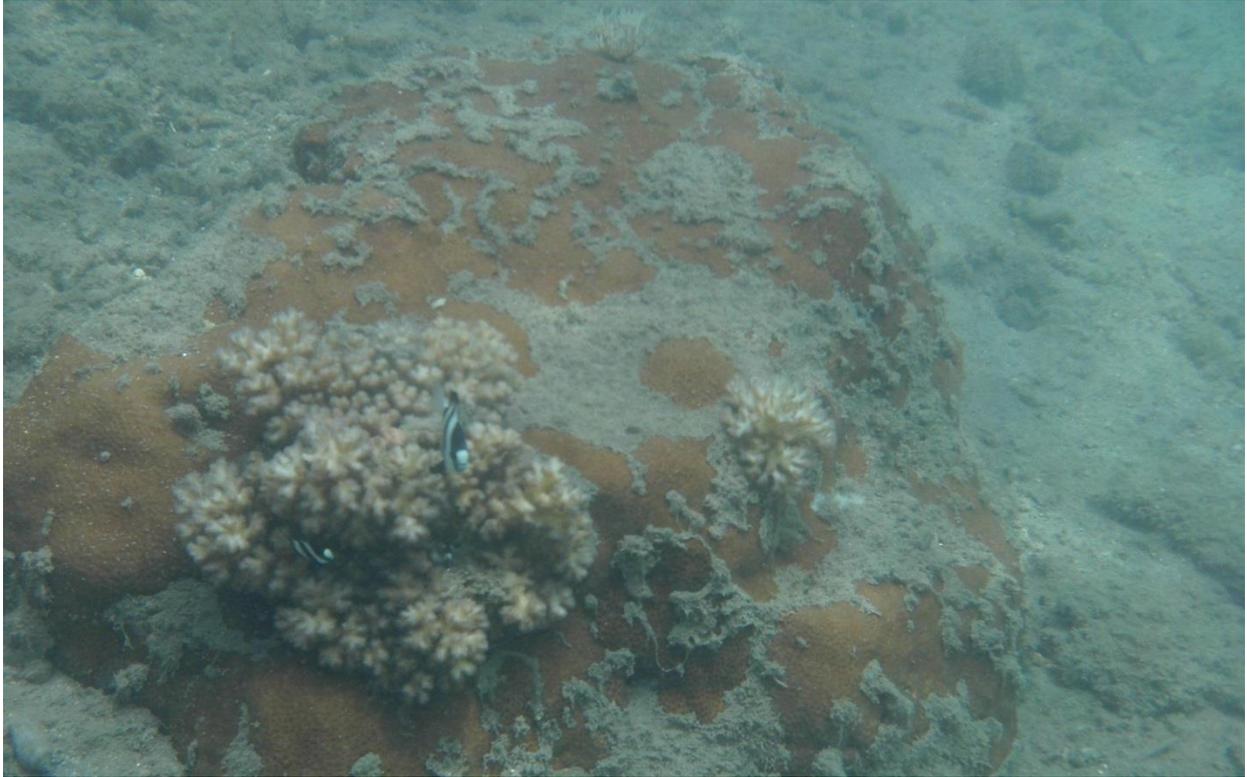
Figure 8 *Pocillopora damicornis* (branching coral) and *Leptastrea purpurea* (massive coral) colonies.

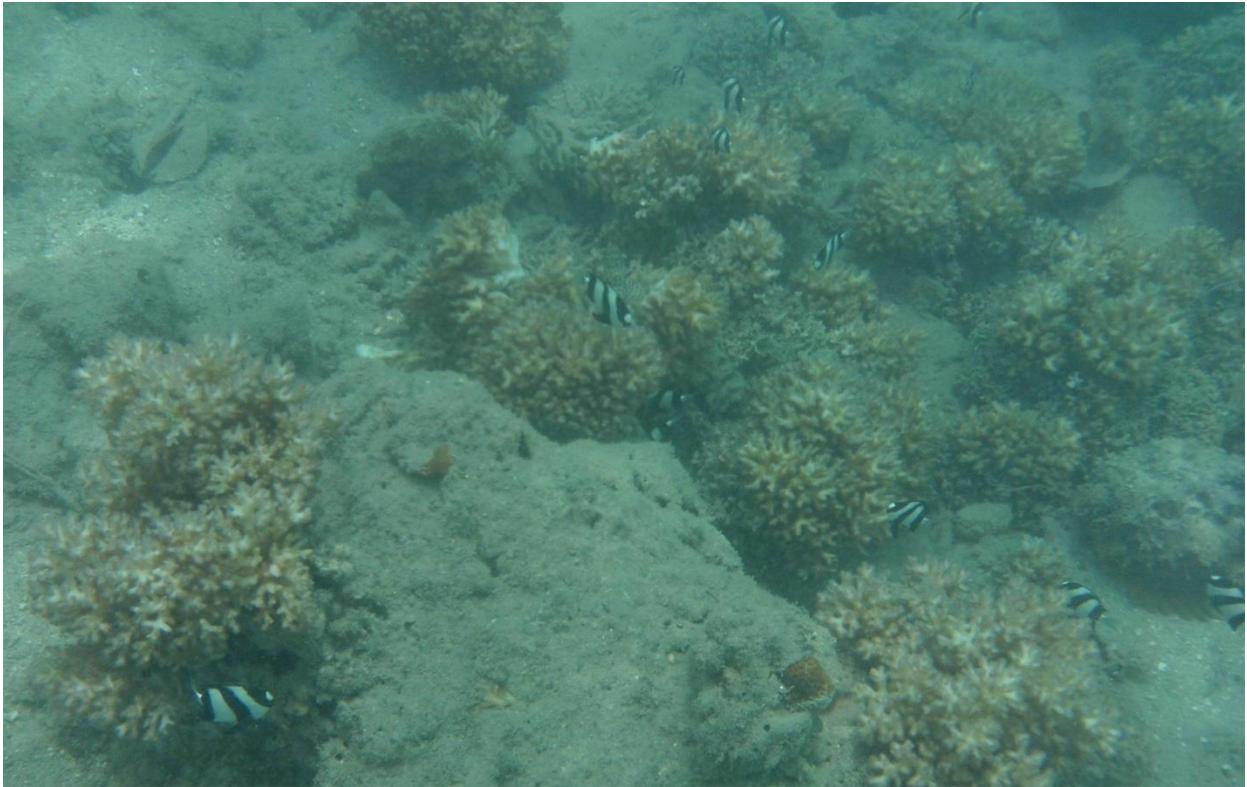
Figure 9 *Pocillopora damicornis* (branching coral) and *Leptastrea purpurea* (massive coral) colonies.
