**GUAM COASTAL MANAGEMENT PROGRAM
FEDERAL CONSISTENCY FORM APPLICATION:
AUSTRALIA-JAPAN CABLE SEGMENT 6 SHALLOW WATER REPAIR
TANGUISSON, GUAM**

JUNE 2016

Subject: Australia-Japan Cable Segment 6 Shallow Water Repair, Tanguisson, Guam

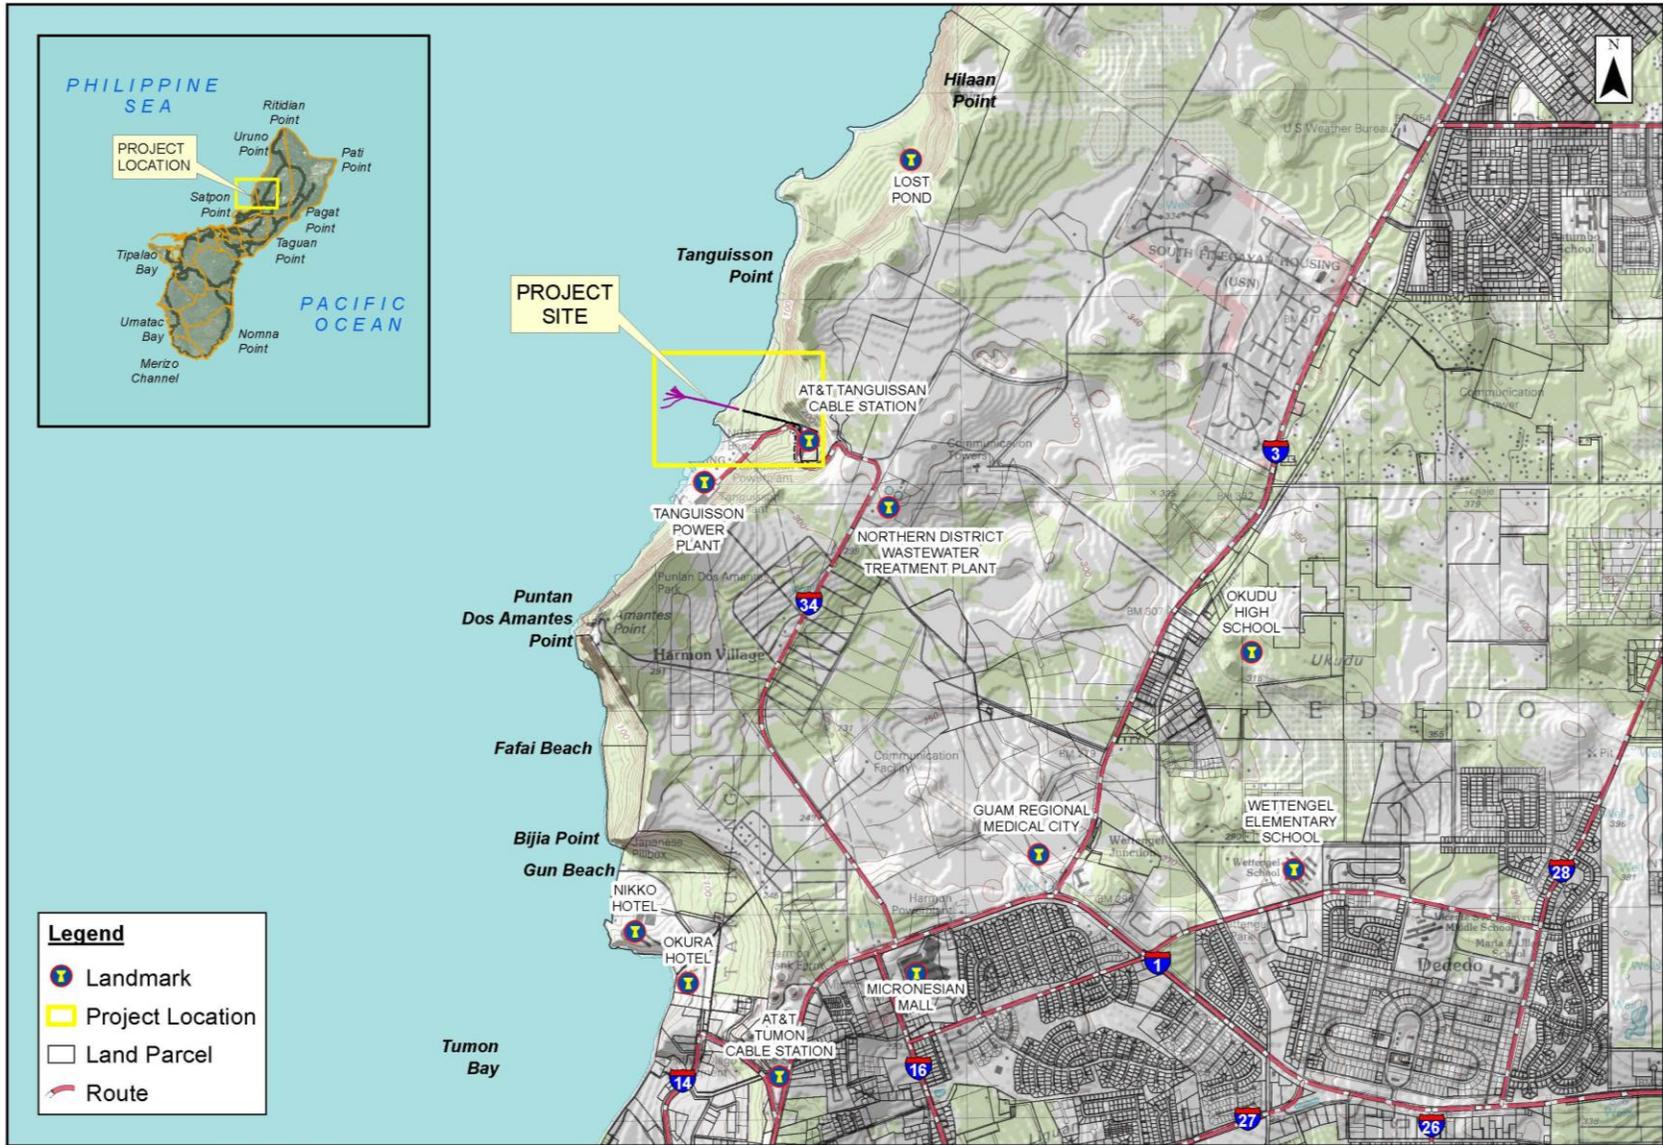
Figure 2. Flood Hazard Areas in the Vicinity of the AJC Project Site at Tanguisson, Guam (Taken from FEMA, 2007).

The Federal Emergency Management Agency (FEMA) Flood Rate Insurance Maps designates the project site off of Tanguisson Beach as Flood Zone A (Figure 2). Zone A encompasses those areas for which no base flood elevation has been determined. The sites lie in areas susceptible to the 1% annual flood, meaning that for any given year, there is a 1 in 100 chance for the area to experience the effects of a 100-year flood (FEMA, 2007). The outlying areas fall within Flood Zone X, which are areas outside the 0.2% chance floodplain.
